## Potable Water Storage Tank

**Project:** Remote Community of Imaluk, NT.

**Category:** Primary Containment – Potable Water

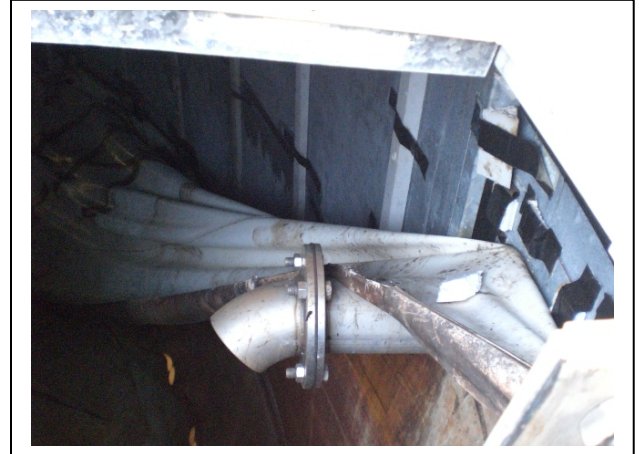
Before...

The Potable Water Storage Tank (16.64m dia x 5m high Panel Tank) at this remote NT Community was first installed in 1997 and the lining had commenced failing some time ago. In late 2007 the lining failure had made the tank inoperative and Rhino Linings was asked to offer a spray on seamless lining so that this community could again have a reliable potable water storage facility.

Staff from Rhino Linings Top End and Rhino Linings Australasia Pty Ltd spent approximately 10 days on-site removing the failed liner, grinding and priming the steel surfaces of the tank and spraying TUFF STUFF as a light grey seamless lining over the walls and floor of the tank. Lining integrity at the bolted joint lines on both the floor and wall was a very important consideration when offering a solution to this failed tank liner. The Rhino Linings team provided an economical and technically efficient means of encapsulation, sealing all joints and fittings throughout the tank.
