Rhino Linings®

Project: Caterpillar 789 Mud Guard
Category: Impact/Corrosion resistance/non conductive
Completion Date: October 2009
System: Rhino Tuff Stuff, Rhino Prime 251, Rhino Top Coat

Job Description

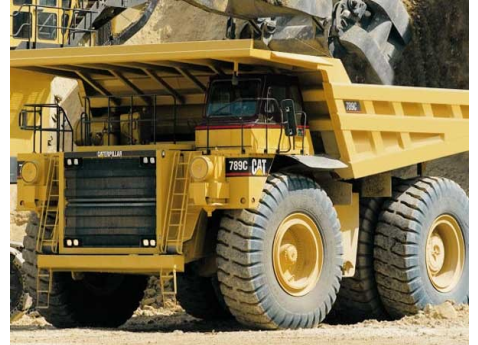
Example of a Caterpillar 789 Haul Truck.

This Caterpillar 789 Haul Truck is part of a fleet used in the highly corrosive environment that exists on a mine site. As can be seen from the first photo, the mud guard is situated directly over the front left hand wheel, it is therefore extremely vulnerable to impact.

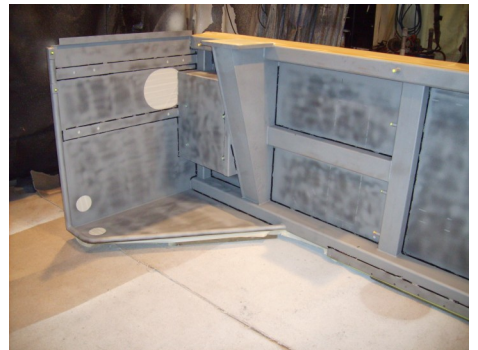
Guard after sandblasting & prep

The guard was first sandblasted and repaired prior to application of Rhino Prime 251. It was then sprayed with Rhino Tuff Stuff. The Rhino Tuff Stuff was applied to the guard at a nominal thickness of 4mm on the underside in the colour of black. The battery box and door were also sprayed to prevent the battery from shorting out on the metal surface should it become dislodged from it's mounting.

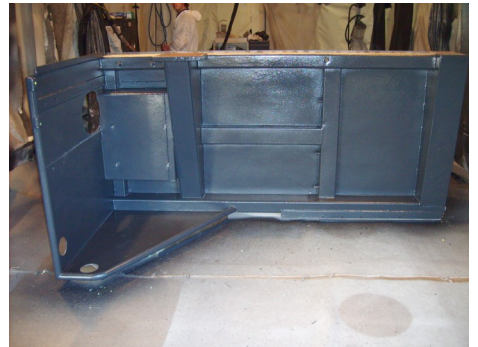
Guard after spraying Rhino Tuff Stuff

The job was completed using a 1/4" fine texture atomizer. The extremely fast cure time of Rhino Tuff Stuff allowed easy application to vertical surfaces.

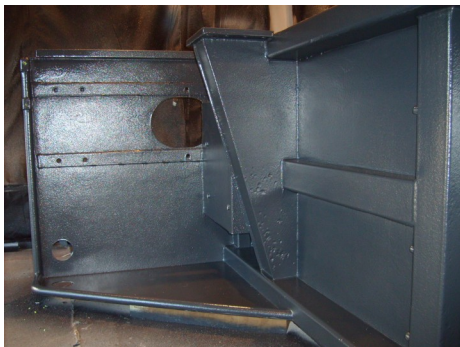
Guard after Rhino Tuff Stuff

The first guard has been in operation for over 18 months and is showing no signs of wear. Since the initial trial a further 3 guards have been sprayed.

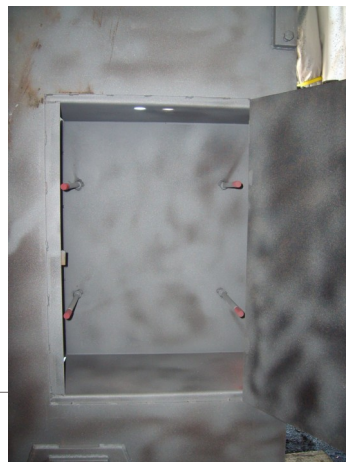
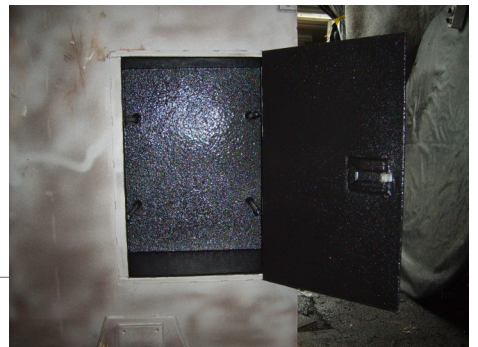
Left: Battery box sandblasted & prep
Below: Battery box with Rhino Tuff Stuff
