Shower Block

Project: Shower Block at Coalmine

Category: Waterproofing

Product: Rhino Linings Duraspray

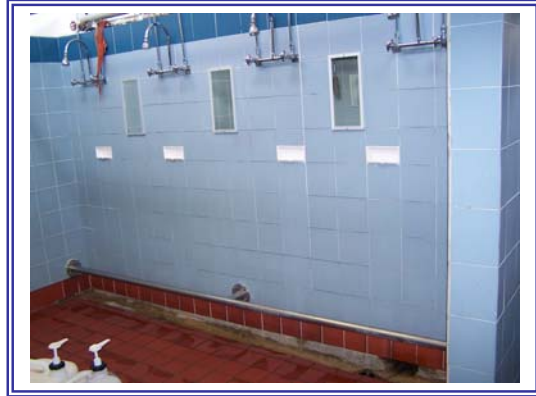
Management of a local coalmine required the shower blocks to be revamped during maintenance shut down.

Both the wall and floor of the shower blocks required lining (a total of 112m square). The job was undertaken in two stages, with the 2 smaller shower blocks completed first, followed by the 3rd shower block.

All areas were washed, cleaned, and acid etched to remove glazing. After masking, 251 Primer was applied followed by Duraspray. Top Coat was then applied along with aggregate for its non slip properties.
